REPORT
On
6 Marion Street
BIRKENHEAD
Wirral
CH41 6LT

On behalf of: Barclays Bank Plc

In respect of: AEV Ltd

Dated: 5th March 2018

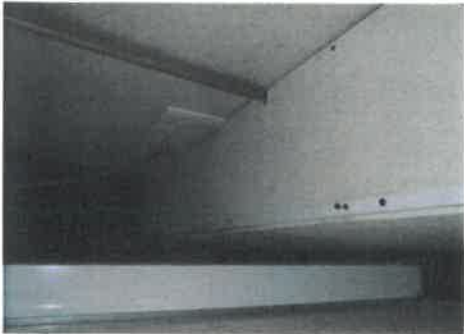
Building / Floor: Offices 1 / Ground Area: R01 Office Location: Ceiling void Product: Board Description: Supalux lining to ceiling Recommended Action: No action required				
Level of ID		Sample			Asbestos Type			Extent	
Sample		001			No asbestos detected			20m2	
Material Risk					Priority Risk				Total risk
Asbestos Product	Damage to Asbestos	Surface Treatment	Asbestos Type	Total Material Score	Room Activity	Room Accessibility	Room Frequency of Use	Room Maintenance Frequency	Total Priority Risk Assessment
N/A	N/A	N/A	N/A	N/A	N/A	N/A	N/A	N/A	N/A
Risk Category		N/A			Inspection Regime			N/A

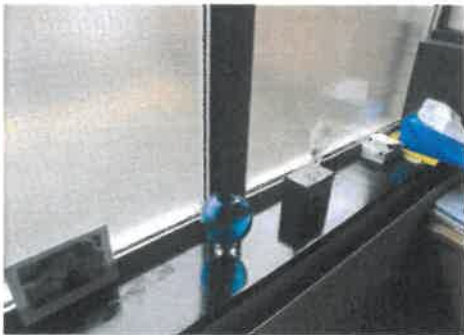
Building / Floor: Offices 1 / Ground Area: R01 Office Location: Windows Product: Resin Description: Sealant to windows Recommended Action: No action required				
Level of ID		Sample			Asbestos Type			Extent	
Sample		002			No asbestos detected				
Material Risk					Priority Risk				Total risk
Asbestos Product	Damage to Asbestos	Surface Treatment	Asbestos Type	Total Material Score	Room Activity	Room Accessibility	Room Frequency of Use	Room Maintenance Frequency	Total Priority Risk Assessment
N/A	N/A	N/A	N/A	N/A	N/A	N/A	N/A	N/A	N/A
Risk Category		N/A			Inspection Regime			N/A

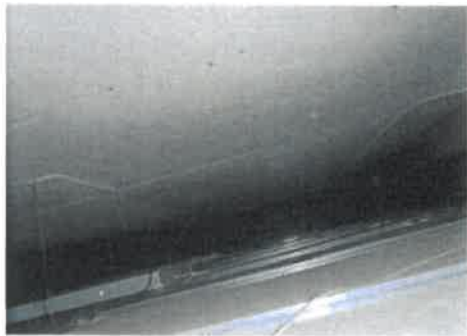
<p>Building / Floor: Offices 1 / Ground Area: R02 Office Location: Ceiling void Product: Board Description: Supalux lining to ceiling Recommended Action: No action required</p>
---	--

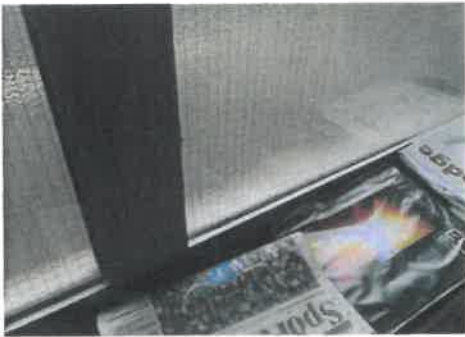
<p>Building / Floor: Offices 1 / Ground Area: R02 Office Location: Windows Product: Resin Description: Sealant to windows Recommended Action: No action required</p>				
Level of ID		Sample		Asbestos Type			Extent		
As sample		As 002		No asbestos detected					
Material Risk					Priority Risk				Total risk
Asbestos Product	Damage to Asbestos	Surface Treatment	Asbestos Type	Total Material Score	Room Activity	Room Accessibility	Room Frequency of Use	Room Maintenance Frequency	Total Priority Risk Assessment
N/A	N/A	N/A	N/A	N/A	N/A	N/A	N/A	N/A	N/A
Risk Category		N/A			Inspection Regime			N/A

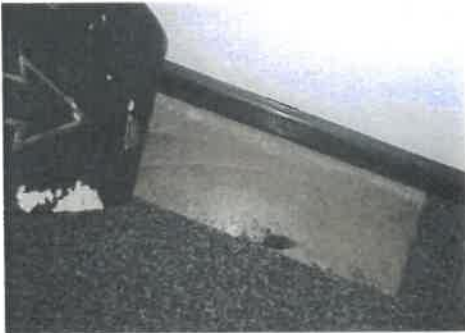
<p>Building / Floor: Offices 1 / Ground Area: R02 Office Location: Floor Product: Resin Description: Adhesive beneath carpet tile overlay (on concrete) Recommended Action: No action required</p>				
Level of ID		Sample		Asbestos Type			Extent		
As sample		As 003		No asbestos detected			12m2		
Material Risk					Priority Risk				Total risk
Asbestos Product	Damage to Asbestos	Surface Treatment	Asbestos Type	Total Material Score	Room Activity	Room Accessibility	Room Frequency of Use	Room Maintenance Frequency	Total Priority Risk Assessment
N/A	N/A	N/A	N/A	N/A	N/A	N/A	N/A	N/A	N/A
Risk Category		N/A			Inspection Regime			N/A

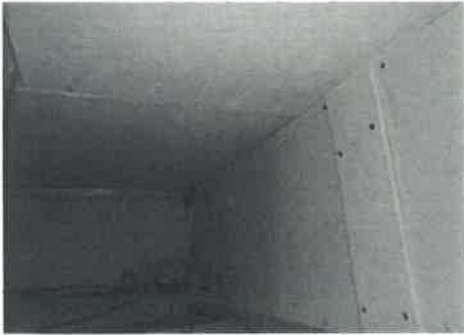
Building / Floor: Offices 1 / Ground Area: R03 Office Location: Ceiling void Product: Board Description: Supalux lining to ceiling Recommended Action: No action required				
					Level of ID		Sample		Asbestos Type
As sample		As 001		No asbestos detected		30m2			
Material Risk					Priority Risk				Total risk
Asbestos Product	Damage to Asbestos	Surface Treatment	Asbestos Type	Total Material Score	Room Activity	Room Accessibility	Room Frequency of Use	Room Maintenance Frequency	Total Priority Risk Assessment
N/A	N/A	N/A	N/A	N/A	N/A	N/A	N/A	N/A	N/A
Risk Category		N/A			Inspection Regime			N/A

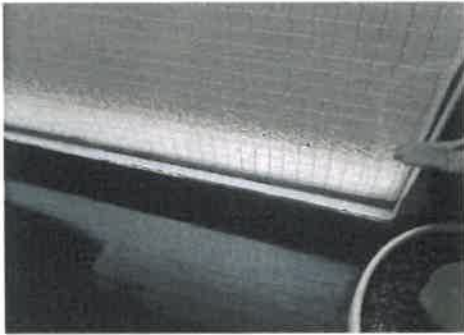
Building / Floor: Offices 1 / Ground Area: R03 Office Location: Windows Product: Resin Description: Sealant to windows Recommended Action: No action required				
					Level of ID		Sample		Asbestos Type
As sample		As 002		No asbestos detected					
Material Risk					Priority Risk				Total risk
Asbestos Product	Damage to Asbestos	Surface Treatment	Asbestos Type	Total Material Score	Room Activity	Room Accessibility	Room Frequency of Use	Room Maintenance Frequency	Total Priority Risk Assessment
N/A	N/A	N/A	N/A	N/A	N/A	N/A	N/A	N/A	N/A
Risk Category		N/A			Inspection Regime			N/A

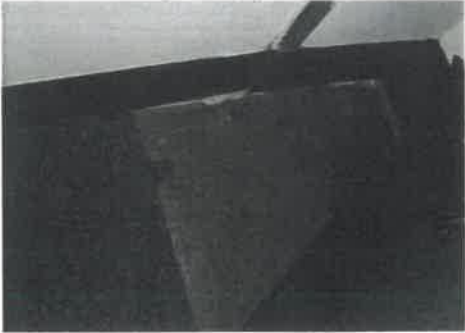
Building / Floor: Offices 1 / Ground Area: R03 Office Location: Floor Product: Resin Description: Adhesive beneath carpet tile overlay (on concrete) Recommended Action: No action required				
Level of ID		Sample		Asbestos Type			Extent		
As sample		As 003		No asbestos detected			30m2		
Material Risk					Priority Risk				Total risk
Asbestos Product	Damage to Asbestos	Surface Treatment	Asbestos Type	Total Material Score	Room Activity	Room Accessibility	Room Frequency of Use	Room Maintenance Frequency	Total Priority Risk Assessment
N/A	N/A	N/A	N/A	N/A	N/A	N/A	N/A	N/A	N/A
Risk Category		N/A			Inspection Regime			N/A

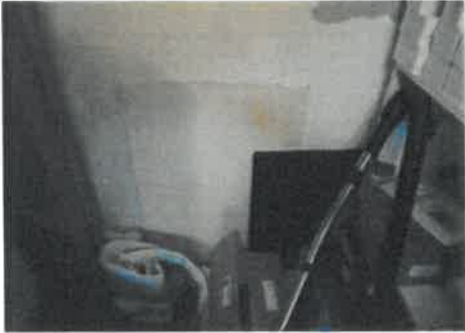
Building / Floor: Offices 1 / Ground Area: R04 Store room Location: Wall void Product: Board Description: No access behind timber panel to wall Recommended Action: Further investigation required prior to any works being carried out that may disturb this material.				
Level of ID		Sample		Asbestos Type			Extent		
Not accessed		P1		Presumed			Throughout		
Material Risk					Priority Risk				Total risk
Asbestos Product	Damage to Asbestos	Surface Treatment	Asbestos Type	Total Material Score	Room Activity	Room Accessibility	Room Frequency of Use	Room Maintenance Frequency	Total Priority Risk Assessment
To be confirmed upon further investigation									
Risk Category		N/A			Inspection Regime			N/A

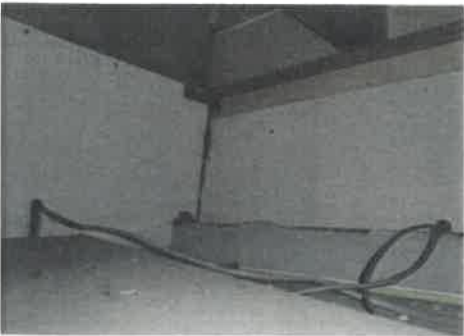
<p>Building / Floor: Offices 1 / Ground Area: R05 Circulation Location: Ceiling void Product: Board Description: Supalux lining to walls Recommended Action: No action required</p>
---	---

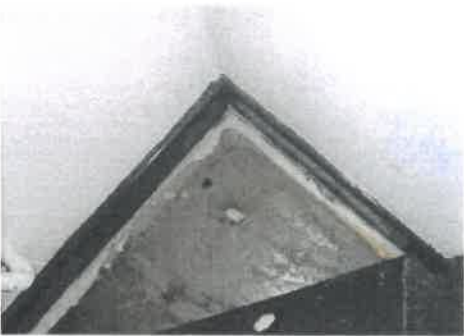
<p>Building / Floor: Offices 1 / Ground Area: R05 Circulation Location: Floor Product: Resin Description: Adhesive beneath carpet tile overlay (on concrete) Recommended Action: No action required</p>
---	---

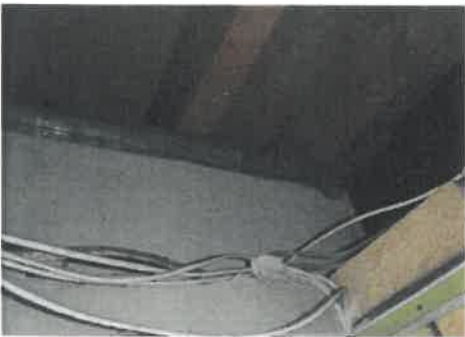
<p>Building / Floor: Offices 1 / Ground Area: R06 Entrance Location: Ceiling void Product: Board Description: Supalux lining to walls Recommended Action: No action required</p>				
Level of ID		Sample		Asbestos Type			Extent		
As sample		As 001		No asbestos detected			4m2		
Material Risk					Priority Risk				Total risk
Asbestos Product	Damage to Asbestos	Surface Treatment	Asbestos Type	Total Material Score	Room Activity	Room Accessibility	Room Frequency of Use	Room Maintenance Frequency	Total Priority Risk Assessment
N/A	N/A	N/A	N/A	N/A	N/A	N/A	N/A	N/A	N/A
Risk Category		N/A			Inspection Regime			N/A

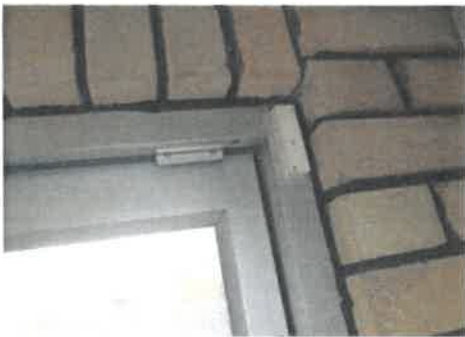
<p>Building / Floor: Offices 1 / Ground Area: R06 Entrance Location: Walls Product: Resin Description: Sealant to door frame Recommended Action: No action required</p>				
Level of ID		Sample		Asbestos Type			Extent		
As sample		As 002		No asbestos detected					
Material Risk					Priority Risk				Total risk
Asbestos Product	Damage to Asbestos	Surface Treatment	Asbestos Type	Total Material Score	Room Activity	Room Accessibility	Room Frequency of Use	Room Maintenance Frequency	Total Priority Risk Assessment
N/A	N/A	N/A	N/A	N/A	N/A	N/A	N/A	N/A	N/A
Risk Category		N/A			Inspection Regime			N/A

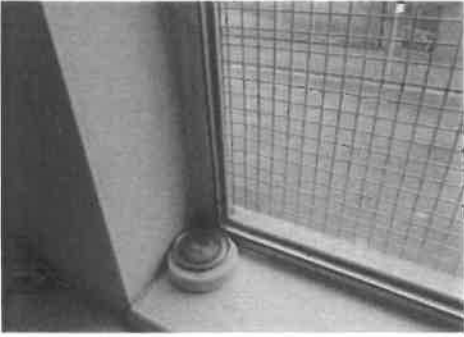
Building / Floor: Offices 1 / First Area: R09 Canteen Location: Windows Product: Resin Description: Sealant to windows Recommended Action: No action required				
Level of ID		Sample			Asbestos Type			Extent	
As sample		As 002			No asbestos detected				
Material Risk					Priority Risk				Total risk
Asbestos Product	Damage to Asbestos	Surface Treatment	Asbestos Type	Total Material Score	Room Activity	Room Accessibility	Room Frequency of Use	Room Maintenance Frequency	Total Priority Risk Assessment
N/A	N/A	N/A	N/A	N/A	N/A	N/A	N/A	N/A	N/A
Risk Category		N/A			Inspection Regime			N/A

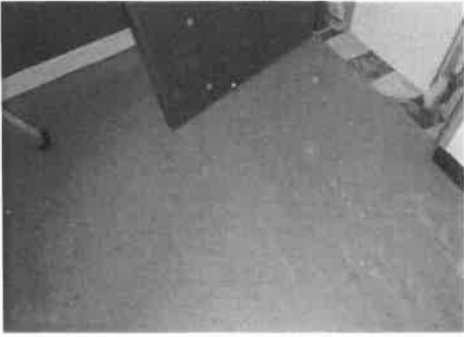
Building / Floor: Offices 1 / First Area: R09 Canteen Location: Floor Product: Vinyl Description: Grey vinyl overlay on timber panel Recommended Action: No action required				
Level of ID		Sample			Asbestos Type			Extent	
Sample		004			No asbestos detected			10m2	
Material Risk					Priority Risk				Total risk
Asbestos Product	Damage to Asbestos	Surface Treatment	Asbestos Type	Total Material Score	Room Activity	Room Accessibility	Room Frequency of Use	Room Maintenance Frequency	Total Priority Risk Assessment
N/A	N/A	N/A	N/A	N/A	N/A	N/A	N/A	N/A	N/A
Risk Category		N/A			Inspection Regime			N/A

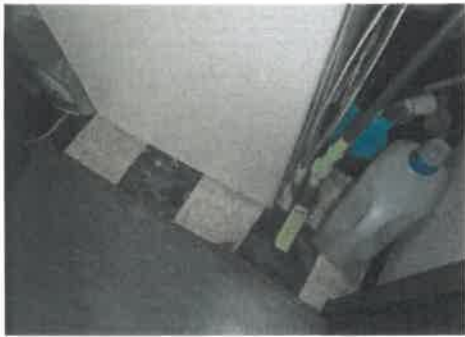
<p>Building / Floor: Offices 1 / First Area: R09a Store room Location: Floor Product: Vinyl Description: Black/white vinyl overlay on timber panel Recommended Action: No action required</p>				
Level of ID		Sample			Asbestos Type			Extent	
Sample		005			No asbestos detected			2m2	
Material Risk					Priority Risk				Total risk
Asbestos Product	Damage to Asbestos	Surface Treatment	Asbestos Type	Total Material Score	Room Activity	Room Accessibility	Room Frequency of Use	Room Maintenance Frequency	Total Priority Risk Assessment
N/A	N/A	N/A	N/A	N/A	N/A	N/A	N/A	N/A	N/A
Risk Category		N/A			Inspection Regime			N/A

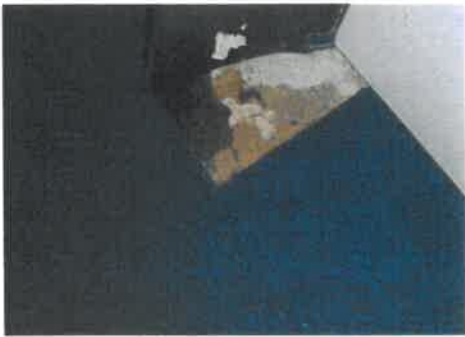
<p>Building / Floor: Offices 1 / First Area: R12 Corridor Location: Floor Product: Resin Description: Adhesive beneath carpet tile overlay (on timber panel) Recommended Action: No action required</p>				
Level of ID		Sample			Asbestos Type			Extent	
Sample		006			No asbestos detected			10m2	
Material Risk					Priority Risk				Total risk
Asbestos Product	Damage to Asbestos	Surface Treatment	Asbestos Type	Total Material Score	Room Activity	Room Accessibility	Room Frequency of Use	Room Maintenance Frequency	Total Priority Risk Assessment
N/A	N/A	N/A	N/A	N/A	N/A	N/A	N/A	N/A	N/A
Risk Category		N/A			Inspection Regime			N/A

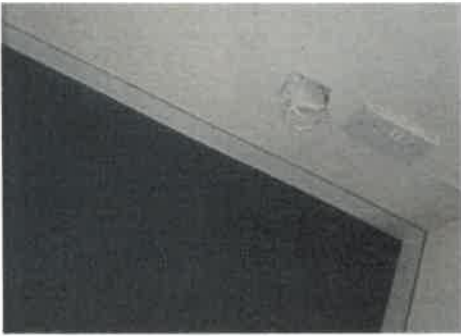
<p>Building / Floor: Offices 1 / First Area: R14 Office Location: Floor Product: Resin Description: Adhesive beneath carpet tile overlay (on timber panel) Recommended Action: No action required</p>
---	---

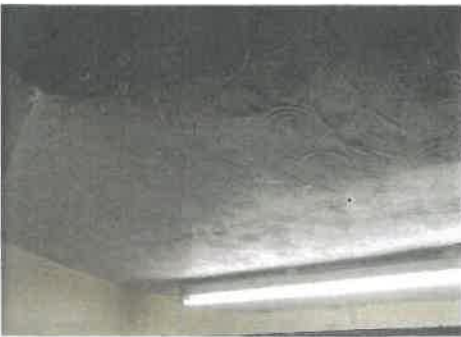
<p>Building / Floor: Offices 2 / Ground Area: R01 Toilet Location: Ceiling Product: Textured coating Description: Textured coating Recommended Action: No action required</p>				
Level of ID		Sample			Asbestos Type			Extent	
Sample		007			No asbestos detected			6m2	
Material Risk					Priority Risk				Total risk
Asbestos Product	Damage to Asbestos	Surface Treatment	Asbestos Type	Total Material Score	Room Activity	Room Accessibility	Room Frequency of Use	Room Maintenance Frequency	Total Priority Risk Assessment
N/A	N/A	N/A	N/A	N/A	N/A	N/A	N/A	N/A	N/A
Risk Category		N/A			Inspection Regime			N/A

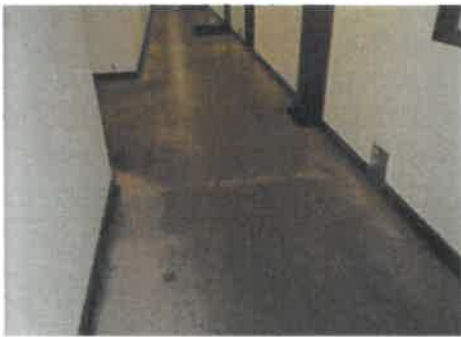
<p>Building / Floor: Offices 2 / Ground Area: R04 Corridor Location: Floor Product: Vinyl Description: Brown vinyl tiles on concrete Recommended Action: No action required</p>				
Level of ID		Sample			Asbestos Type			Extent	
Sample		008			No asbestos detected			70m2	
Material Risk					Priority Risk				Total risk
Asbestos Product	Damage to Asbestos	Surface Treatment	Asbestos Type	Total Material Score	Room Activity	Room Accessibility	Room Frequency of Use	Room Maintenance Frequency	Total Priority Risk Assessment
N/A	N/A	N/A	N/A	N/A	N/A	N/A	N/A	N/A	N/A
Risk Category		N/A			Inspection Regime			N/A

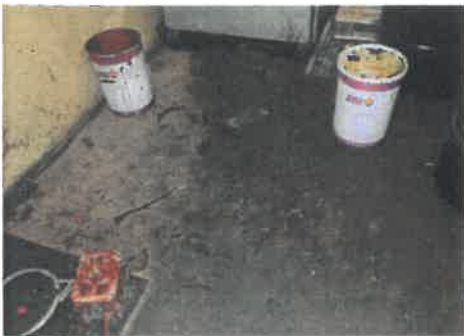
<p>Building / Floor: Offices 2 / Ground Area: R07 Location: Floor Product: Vinyl Description: Brown vinyl tiles on concrete Recommended Action: No action required</p>
---	--

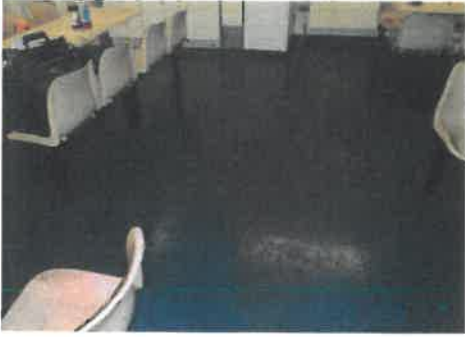
<p>Building / Floor: Offices 2 / Ground Area: R10 Canteen Location: Floor Product: Vinyl Description: Brown vinyl tiles- painted blue Recommended Action: No action required</p>				
Level of ID		Sample			Asbestos Type			Extent	
As sample		As 008			No asbestos detected			30m2	
Material Risk					Priority Risk				Total risk
Asbestos Product	Damage to Asbestos	Surface Treatment	Asbestos Type	Total Material Score	Room Activity	Room Accessibility	Room Frequency of Use	Room Maintenance Frequency	Total Priority Risk Assessment
N/A	N/A	N/A	N/A	N/A	N/A	N/A	N/A	N/A	N/A
Risk Category		N/A			Inspection Regime			N/A

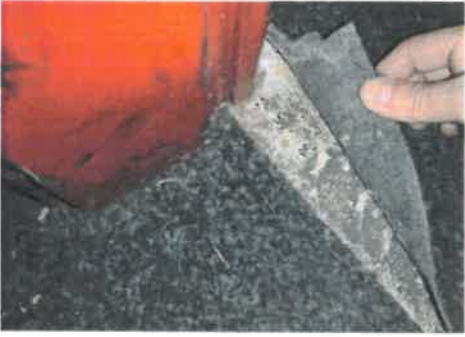
<p>Building / Floor: Offices 2 / Ground Area: R12 Location: Floor Product: Vinyl Description: Brown vinyl tiles below carpet overlay Recommended Action: No action required</p>				
Level of ID		Sample			Asbestos Type			Extent	
As sample		As 008			No asbestos detected			6m2	
Material Risk					Priority Risk				Total risk
Asbestos Product	Damage to Asbestos	Surface Treatment	Asbestos Type	Total Material Score	Room Activity	Room Accessibility	Room Frequency of Use	Room Maintenance Frequency	Total Priority Risk Assessment
N/A	N/A	N/A	N/A	N/A	N/A	N/A	N/A	N/A	N/A
Risk Category		N/A			Inspection Regime			N/A

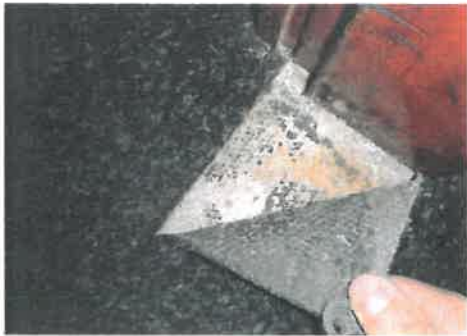
<p>Building / Floor: Offices 2 / Ground Area: R13 Office Location: Floor Product: Vinyl Description: Brown vinyl tiles below carpet overlay Recommended Action: No action required</p>
---	--

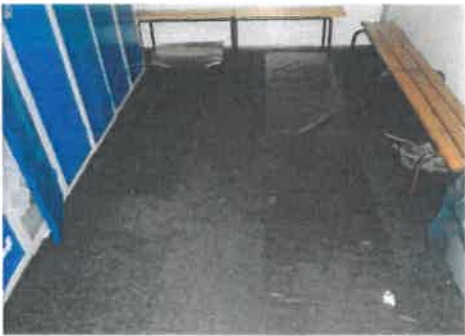
<p>Building / Floor: Offices 2 / Ground Area: R15 Locker room Location: Floor Product: Vinyl Description: Brown vinyl tiles below carpet overlay Recommended Action: No action required</p>
---	---

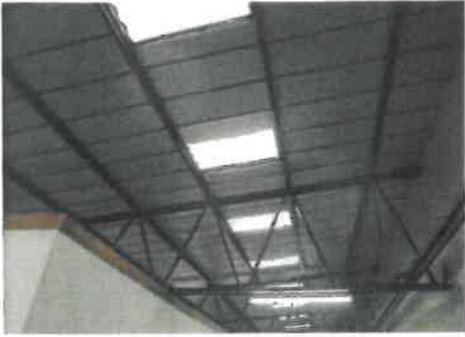
<p>Building / Floor: Offices 2 / First Area: R18 Store Location: Ceiling Product: Cement Description: Preformed corrugated sheets above plasterboard ceiling panels Recommended Action: Label as containing asbestos & manage in situ. Inspect & record condition at recommended intervals. Repairs/removals must be carried out by appropriately qualified persons under controlled conditions.</p>				
Level of ID		Sample		Asbestos Type			Extent		
Strongly presumed		SP1		Chrysotile			Throughout		
Material Risk					Priority Risk				Total risk
Asbestos Product	Damage to Asbestos	Surface Treatment	Asbestos Type	Total Material Score	Room Activity	Room Accessibility	Room Frequency of Use	Room Maintenance Frequency	Total Priority Risk Assessment
1	0	1	1	3	1	2	2	0	6
Risk Category		Very low risk			Inspection Regime			12 monthly

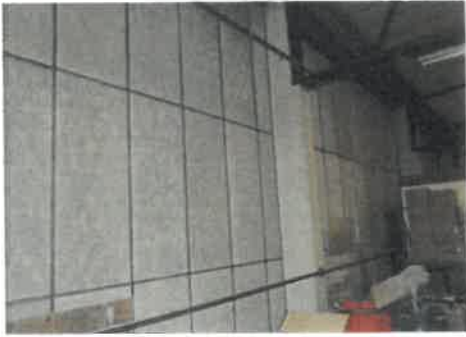
<p>Building / Floor: Offices 2 / First Area: R18 Store Location: Walls Product: Board Description: Supalux panel lining to wall Recommended Action: No action required</p>				
Level of ID		Sample		Asbestos Type			Extent		
Sample		011		No asbestos detected			120m2		
Material Risk					Priority Risk				Total risk
Asbestos Product	Damage to Asbestos	Surface Treatment	Asbestos Type	Total Material Score	Room Activity	Room Accessibility	Room Frequency of Use	Room Maintenance Frequency	Total Priority Risk Assessment
N/A	N/A	N/A	N/A	N/A	N/A	N/A	N/A	N/A	N/A
Risk Category		N/A			Inspection Regime			N/A

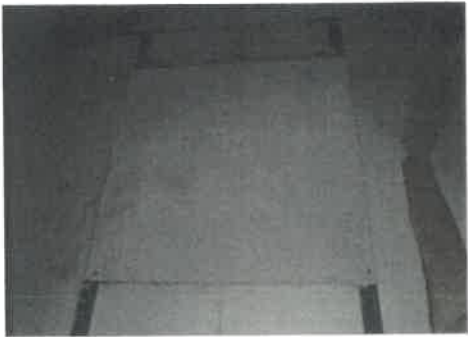
Building / Floor: Offices 2 / First Area: R18 Store Location: Walls Product: Board Description: Supalux panel Recommended Action: No action required				
Level of ID		Sample		Asbestos Type			Extent		
As sample		As 009		No asbestos detected			1m2		
Material Risk					Priority Risk				Total risk
Asbestos Product	Damage to Asbestos	Surface Treatment	Asbestos Type	Total Material Score	Room Activity	Room Accessibility	Room Frequency of Use	Room Maintenance Frequency	Total Priority Risk Assessment
N/A	N/A	N/A	N/A	N/A	N/A	N/A	N/A	N/A	N/A
Risk Category		N/A			Inspection Regime			N/A

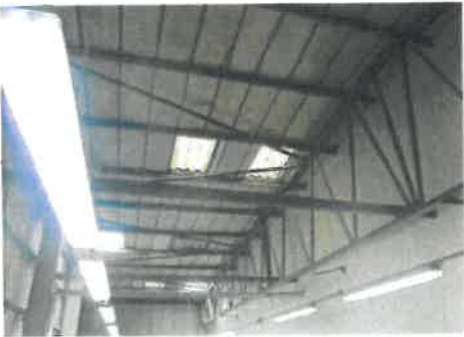
Building / Floor: Warehouse / Ground Area: Area 1 Location: Ceiling Product: Cement Description: Preformed corrugated sheets above plasterboard ceiling panels Recommended Action: Label as containing asbestos & manage in situ. Inspect & record condition at recommended intervals. Repairs/ removals must be carried out by appropriately qualified persons under controlled conditions.				
Level of ID		Sample		Asbestos Type			Extent		
Strongly presumed		SP2		Chrysotile			Throughout		
Material Risk					Priority Risk				Total risk
Asbestos Product	Damage to Asbestos	Surface Treatment	Asbestos Type	Total Material Score	Room Activity	Room Accessibility	Room Frequency of Use	Room Maintenance Frequency	Total Priority Risk Assessment
1	0	1	1	3	1	2	2	0	8
Risk Category		Very low risk			Inspection Regime			12 monthly

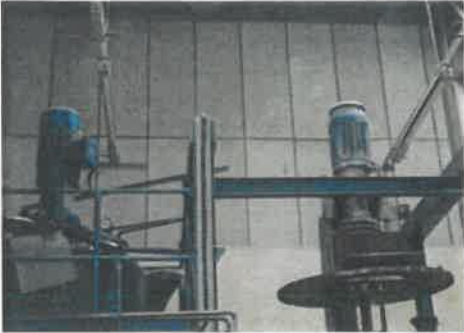
<p>Building / Floor: Warehouse / Ground Area: Area 1 Location: Walls Product: Board Description: Supalux panel lining to wall Recommended Action: No action required</p>				
Level of ID		Sample			Asbestos Type			Extent	
As sample		As 011			No asbestos detected			120m2	
Material Risk					Priority Risk				Total risk
Asbestos Product	Damage to Asbestos	Surface Treatment	Asbestos Type	Total Material Score	Room Activity	Room Accessibility	Room Frequency of Use	Room Maintenance Frequency	Total Priority Risk Assessment
N/A	N/A	N/A	N/A	N/A	N/A	N/A	N/A	N/A	N/A
Risk Category		N/A			Inspection Regime			N/A

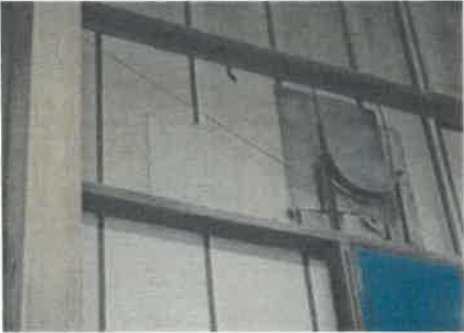
<p>Building / Floor: Warehouse / Ground Area: Area 1 Location: Walls Product: Board Description: Supalux panel Recommended Action: No action required</p>				
Level of ID		Sample			Asbestos Type			Extent	
As sample		As 009			No asbestos detected			1m2	
Material Risk					Priority Risk				Total risk
Asbestos Product	Damage to Asbestos	Surface Treatment	Asbestos Type	Total Material Score	Room Activity	Room Accessibility	Room Frequency of Use	Room Maintenance Frequency	Total Priority Risk Assessment
N/A	N/A	N/A	N/A	N/A	N/A	N/A	N/A	N/A	N/A
Risk Category		N/A			Inspection Regime			N/A

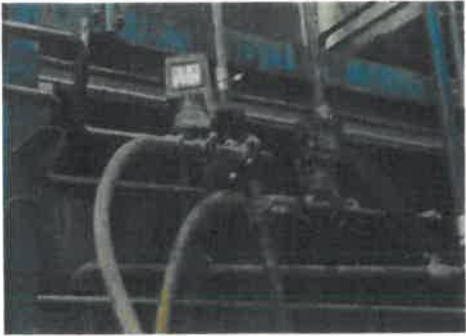
<p>Building / Floor: Warehouse / Ground Area: Area 1 Location: Machinery Product: Gasket Description: Presumed gaskets to flanges Recommended Action: Label as potentially containing asbestos. Monitor & record the condition at regular intervals. Further investigation required prior to any works being carried out that may disturb this material.</p>
---	--

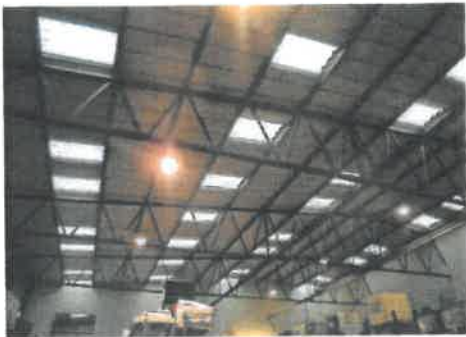
Building / Floor: Warehouse / Ground Area: Area 2 Location: Ceiling Product: Cement Description: Preformed corrugated sheets above plasterboard ceiling panels Recommended Action: Label as containing asbestos & manage in situ. Inspect & record condition at recommended intervals. Repairs/removals must be carried out by appropriately qualified persons under controlled conditions.				
Level of ID		Sample			Asbestos Type			Extent	
Strongly presumed		SP3			Chrysotile			Throughout	
Material Risk					Priority Risk				Total risk
Asbestos Product	Damage to Asbestos	Surface Treatment	Asbestos Type	Total Material Score	Room Activity	Room Accessibility	Room Frequency of Use	Room Maintenance Frequency	Total Priority Risk Assessment
1	0	1	1	3	1	2	2	0	8
Risk Category		Very low risk			Inspection Regime			12 monthly

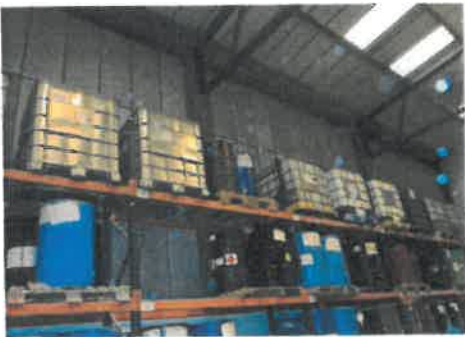
Building / Floor: Warehouse / Ground Area: Area 2 Location: Walls Product: Board Description: Supalux panel lining to wall Recommended Action: No action required				
Level of ID		Sample			Asbestos Type			Extent	
As sample		As 011			No asbestos detected			<500m2	
Material Risk					Priority Risk				Total risk
Asbestos Product	Damage to Asbestos	Surface Treatment	Asbestos Type	Total Material Score	Room Activity	Room Accessibility	Room Frequency of Use	Room Maintenance Frequency	Total Priority Risk Assessment
N/A	N/A	N/A	N/A	N/A	N/A	N/A	N/A	N/A	N/A
Risk Category		N/A			Inspection Regime			N/A

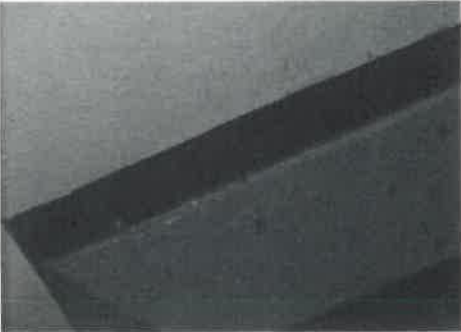
<p>Building / Floor: Warehouse / Ground Area: Area 2 Location: Floor Product: Vinyl Description: Vinyl skirting to wall Recommended Action: No action required</p>				
Level of ID		Sample			Asbestos Type			Extent	
As sample		As 012			No asbestos detected			30 Lm	
Material Risk					Priority Risk				Total risk
Asbestos Product	Damage to Asbestos	Surface Treatment	Asbestos Type	Total Material Score	Room Activity	Room Accessibility	Room Frequency of Use	Room Maintenance Frequency	Total Priority Risk Assessment
N/A	N/A	N/A	N/A	N/A	N/A	N/A	N/A	N/A	N/A
Risk Category		N/A			Inspection Regime			N/A

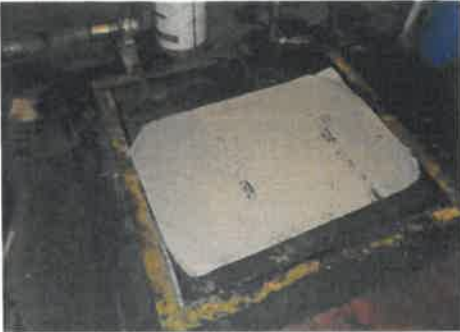
<p>Building / Floor: Warehouse / Ground Area: Area 2 Location: Floor void Product: Not applicable Description: 11/04/2016 - No suspect materials seen within floor void Recommended Action: No action required</p>				
Level of ID		Sample			Asbestos Type			Extent	
Visually inspected		-			No suspect materials			-	
Material Risk					Priority Risk				Total risk
Asbestos Product	Damage to Asbestos	Surface Treatment	Asbestos Type	Total Material Score	Room Activity	Room Accessibility	Room Frequency of Use	Room Maintenance Frequency	Total Priority Risk Assessment
N/A	N/A	N/A	N/A	N/A	N/A	N/A	N/A	N/A	N/A
Risk Category		N/A			Inspection Regime			N/A

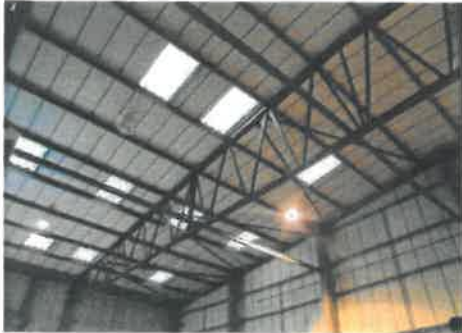
<p>Building / Floor: Warehouse / Ground Area: Area 3 Location: Ceiling Product: Cement Description: Preformed corrugated sheets above plasterboard ceiling panels Recommended Action: Label as containing asbestos & manage in situ. Inspect & record condition at recommended intervals. Repairs/removals must be carried out by appropriately qualified persons under controlled conditions.</p>				
Level of ID		Sample		Asbestos Type			Extent		
Strongly presumed		SP4		Chrysotile			Throughout		
Material Risk					Priority Risk				Total risk
Asbestos Product	Damage to Asbestos	Surface Treatment	Asbestos Type	Total Material Score	Room Activity	Room Accessibility	Room Frequency of Use	Room Maintenance Frequency	Total Priority Risk Assessment
1	0	1	1	3	1	2	2	0	8
Risk Category		Very low risk			Inspection Regime			12 monthly

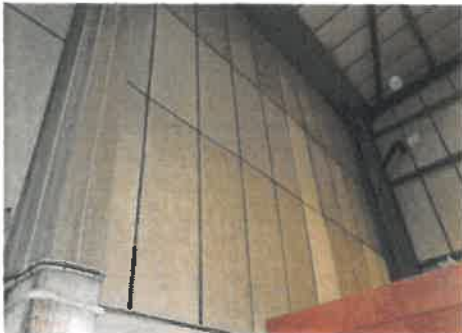
<p>Building / Floor: Warehouse / Ground Area: Area 3 Location: Walls Product: Board Description: Supalux panel lining to wall Recommended Action: No action required</p>				
Level of ID		Sample		Asbestos Type			Extent		
As sample		As 011		No asbestos detected			<500m2		
Material Risk					Priority Risk				Total risk
Asbestos Product	Damage to Asbestos	Surface Treatment	Asbestos Type	Total Material Score	Room Activity	Room Accessibility	Room Frequency of Use	Room Maintenance Frequency	Total Priority Risk Assessment
N/A	N/A	N/A	N/A	N/A	N/A	N/A	N/A	N/A	N/A
Risk Category		N/A			Inspection Regime			N/A

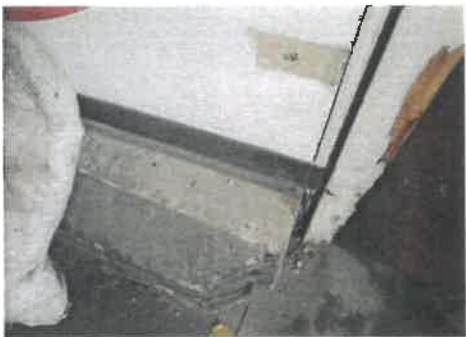
Building / Floor: Warehouse / Ground Area: Area 3 Location: Floor Product: Vinyl Description: Vinyl skirting to wall Recommended Action: No action required				
Level of ID		Sample		Asbestos Type		Extent			
As sample		As 012		No asbestos detected		30 Lm			
Material Risk					Priority Risk				Total risk
Asbestos Product	Damage to Asbestos	Surface Treatment	Asbestos Type	Total Material Score	Room Activity	Room Accessibility	Room Frequency of Use	Room Maintenance Frequency	Total Priority Risk Assessment
N/A	N/A	N/A	N/A	N/A	N/A	N/A	N/A	N/A	N/A
Risk Category		N/A			Inspection Regime			N/A

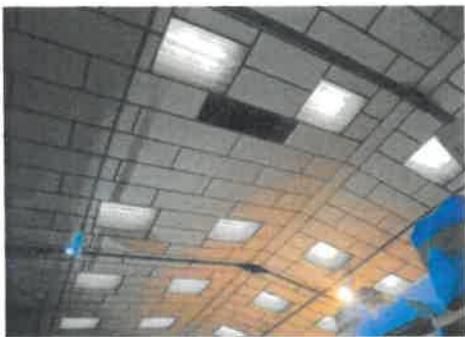
Building / Floor: Warehouse / Ground Area: Area 4 Location: Ceiling Product: Cement Description: Preformed corrugated sheets above plasterboard ceiling panels Recommended Action: Label as containing asbestos & manage in situ. Inspect & record condition at recommended intervals. Repairs/removals must be carried out by appropriately qualified persons under controlled conditions.				
Level of ID		Sample		Asbestos Type		Extent			
Strongly presumed		SP5		Chrysotile		Throughout			
Material Risk					Priority Risk				Total risk
Asbestos Product	Damage to Asbestos	Surface Treatment	Asbestos Type	Total Material Score	Room Activity	Room Accessibility	Room Frequency of Use	Room Maintenance Frequency	Total Priority Risk Assessment
1	0	1	1	3	1	2	2	0	8
Risk Category		Very low risk			Inspection Regime			12 monthly

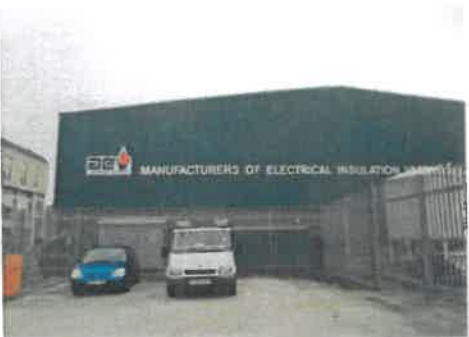
Building / Floor: Whole site Area: External Location: Roof Product: Cement Description: Preformed corrugated sheets (visual from internal) may also be below metal profile sheets Recommended Action: Manage in situ. Inspect & record condition at recommended intervals. Repairs/ removals must be carried out by appropriately qualified persons under controlled conditions.				
					Level of ID		Sample		Asbestos Type
Strongly presumed		SP6		Chrysotile		Throughout			
Material Risk					Priority Risk				Total risk
Asbestos Product	Damage to Asbestos	Surface Treatment	Asbestos Type	Total Material Score	Room Activity	Room Accessibility	Room Frequency of Use	Room Maintenance Frequency	Total Priority Risk Assessment
1	0	1	1	3	1	1	2	0	7
Risk Category		Very low risk			Inspection Regime			12 monthly
