REPORT
On
6 Marion Street
BIRKENHEAD
Wirral
CH41 6LT

On behalf of: Proplend Security Ltd

In respect of: AEV Ltd

Dated: 5th March 2018

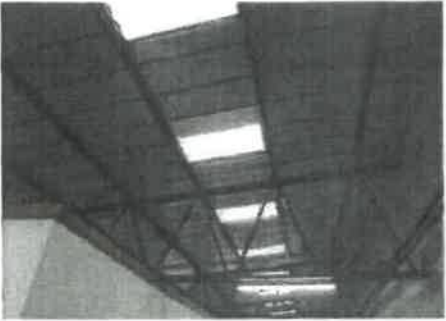
<p>Building / Floor: Offices 2 / First Area: R18 Store Location: Ceiling Product: Cement Description: Preformed corrugated sheets above plasterboard ceiling panels Recommended Action: Label as containing asbestos & manage in situ. Inspect & record condition at recommended intervals. Repairs/removals must be carried out by appropriately qualified persons under controlled conditions.</p>				
Level of ID		Sample			Asbestos Type			Extent	
Strongly presumed		SP1			Chrysotile			Throughout	
Material Risk					Priority Risk				Total risk
Asbestos Product	Damage to Asbestos	Surface Treatment	Asbestos Type	Total Material Score	Room Activity	Room Accessibility	Room Frequency of Use	Room Maintenance Frequency	Total Priority Risk Assessment
1	0	1	1	3	1	2	2	0	8
Risk Category		Very low risk			Inspection Regime			12 monthly

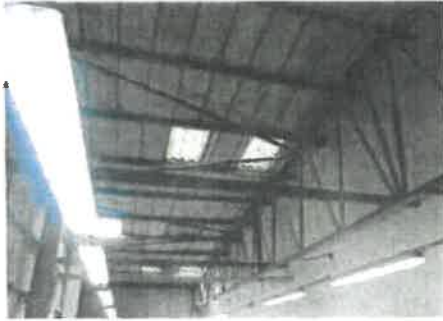
Building / Floor: Warehouse / Ground Area: Area 1 Location: Ceiling Product: Cement Description: Preformed corrugated sheets above plasterboard ceiling panels Recommended Action: Label as containing asbestos & manage in situ. Inspect & record condition at recommended intervals. Repairs/ removals must be carried out by appropriately qualified persons under controlled conditions.				
Level of ID		Sample		Asbestos Type			Extent		
Strongly presumed		SP2		Chrysotile			Throughout		
Material Risk					Priority Risk				Total risk
Asbestos Product	Damage to Asbestos	Surface Treatment	Asbestos Type	Total Material Score	Room Activity	Room Accessibility	Room Frequency of Use	Room Maintenance Frequency	Total Priority Risk Assessment
1	0	1	1	3	1	2	2	0	8
Risk Category		Very low risk			Inspection Regime			12 monthly

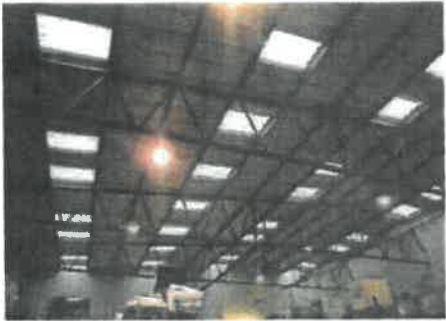
<p>Building / Floor: Warehouse / Ground Area: Area 2 Location: Ceiling Product: Cement Description: Preformed corrugated sheets above plasterboard ceiling panels Recommended Action: Label as containing asbestos & manage in situ. Inspect & record condition at recommended intervals. Repairs/removals must be carried out by appropriately qualified persons under controlled conditions.</p>				
Level of ID		Sample			Asbestos Type			Extent	
Strongly presumed		SP3			Chrysotile			Throughout	
Material Risk					Priority Risk				Total risk
Asbestos Product	Damage to Asbestos	Surface Treatment	Asbestos Type	Total Material Score	Room Activity	Room Accessibility	Room Frequency of Use	Room Maintenance Frequency	Total Priority Risk Assessment
1	0	1	1	3	1	2	2	0	8
Risk Category		Very low risk			Inspection Regime			12 monthly

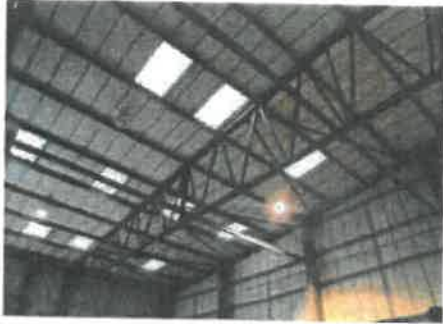
Building / Floor: Warehouse / Ground Area: Area 3 Location: Ceiling Product: Cement Description: Preformed corrugated sheets above plasterboard ceiling panels Recommended Action: Label as containing asbestos & manage in situ. Inspect & record condition at recommended intervals. Repairs/removals must be carried out by appropriately qualified persons under controlled conditions.				
Level of ID		Sample			Asbestos Type		Extent		
Strongly presumed		SP4			Chrysotile		Throughout		
Material Risk					Priority Risk				Total risk
Asbestos Product	Damage to Asbestos	Surface Treatment	Asbestos Type	Total Material Score	Room Activity	Room Accessibility	Room Frequency of Use	Room Maintenance Frequency	Total Priority Risk Assessment
1	0	1	1	3	1	2	2	0	8
Risk Category		Very low risk			Inspection Regime			12 monthly

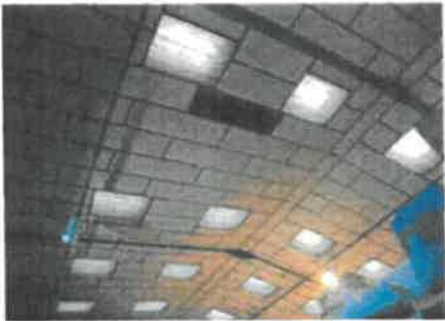
Building / Floor: Warehouse / Ground Area: Area 4 Location: Ceiling Product: Cement Description: Preformed corrugated sheets above plasterboard ceiling panels Recommended Action: Label as containing asbestos & manage in situ. Inspect & record condition at recommended intervals. Repairs/ removals must be carried out by appropriately qualified persons under controlled conditions.				
Level of ID		Sample			Asbestos Type			Extent	
Strongly presumed		SP5			Chrysotile			Throughout	
Material Risk					Priority Risk				Total risk
Asbestos Product	Damage to Asbestos	Surface Treatment	Asbestos Type	Total Material Score	Room Activity	Room Accessibility	Room Frequency of Use	Room Maintenance Frequency	Total Priority Risk Assessment
1	0	1	1	3	1	2	2	0	8
Risk Category		Very low risk			Inspection Regime			12 monthly
