REPORT
On
6 Marion Street
BIRKENHEAD
Wirral
CH41 6LT

On behalf of: Proplend Security Ltd

In respect of: AEV Ltd

Dated: 5th March 2018

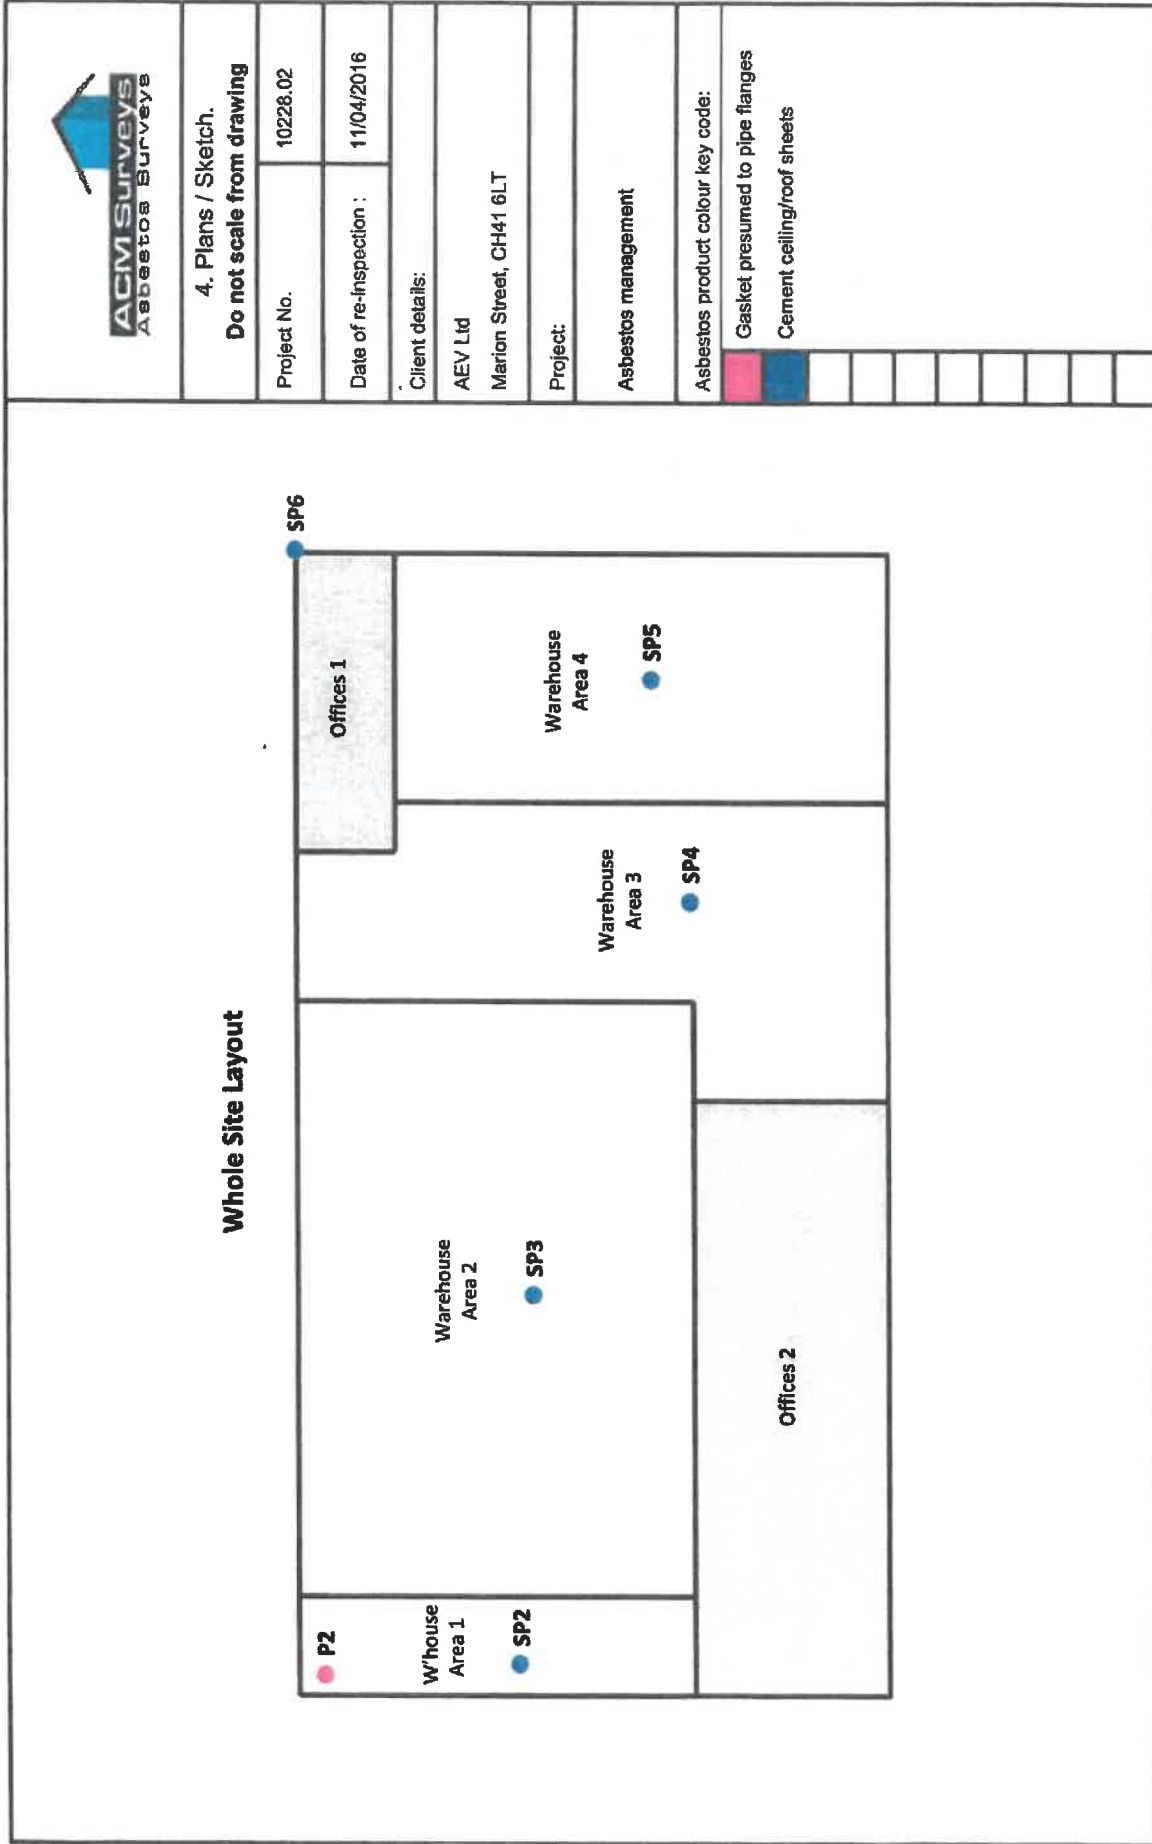
4. Plans / Sketch.
Do not scale from drawing

Gasket presumed to pipe flanges

Cement ceiling/roof sheets

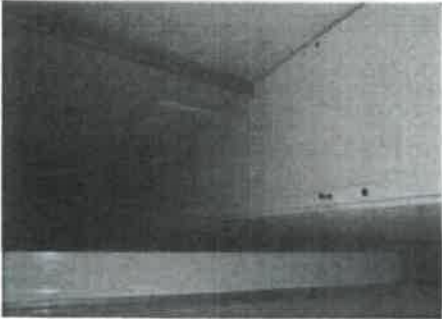
Building / Floor: Offices 1 / Ground Area: R01 Office Location: Ceiling void Product: Board Description: Supalux lining to ceiling Recommended Action: No action required				
Level of ID		Sample		Asbestos Type			Extent		
Sample		001		No asbestos detected			20m2		
Material Risk					Priority Risk				Total risk
Asbestos Product	Damage to Asbestos	Surface Treatment	Asbestos Type	Total Material Score	Room Activity	Room Accessibility	Room Frequency of Use	Room Maintenance Frequency	Total Priority Risk Assessment
N/A	N/A	N/A	N/A	N/A	N/A	N/A	N/A	N/A	N/A
Risk Category		N/A			Inspection Regime			N/A

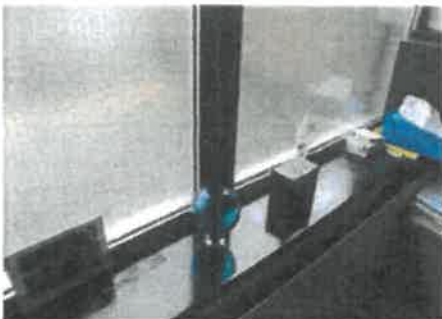
Building / Floor: Offices 1 / Ground Area: R01 Office Location: Windows Product: Resin Description: Sealant to windows Recommended Action: No action required				
Level of ID		Sample		Asbestos Type			Extent		
Sample		002		No asbestos detected					
Material Risk					Priority Risk				Total risk
Asbestos Product	Damage to Asbestos	Surface Treatment	Asbestos Type	Total Material Score	Room Activity	Room Accessibility	Room Frequency of Use	Room Maintenance Frequency	Total Priority Risk Assessment
N/A	N/A	N/A	N/A	N/A	N/A	N/A	N/A	N/A	N/A
Risk Category		N/A			Inspection Regime			N/A

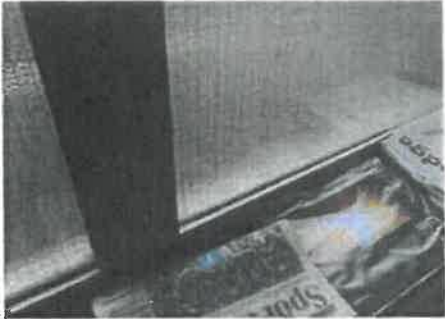
Building / Floor: Offices 1 / Ground Area: R02 Office Location: Windows Product: Resin Description: Sealant to windows Recommended Action: No action required				
Level of ID		Sample			Asbestos Type			Extent	
As sample		As 002			No asbestos detected				
Material Risk					Priority Risk				Total risk
Asbestos Product	Damage to Asbestos	Surface Treatment	Asbestos Type	Total Material Score	Room Activity	Room Accessibility	Room Frequency of Use	Room Maintenance Frequency	Total Priority Risk Assessment
N/A	N/A	N/A	N/A	N/A	N/A	N/A	N/A	N/A	N/A
Risk Category		N/A			Inspection Regime			N/A

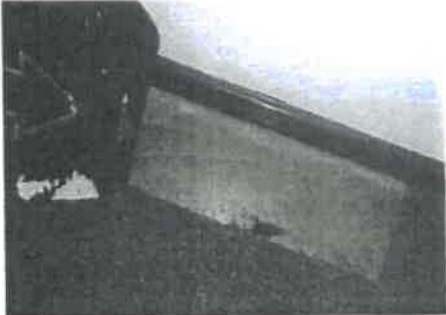
Building / Floor: Offices 1 / Ground Area: R02 Office Location: Floor Product: Resin Description: Adhesive beneath carpet tile overlay (on concrete) Recommended Action: No action required				
Level of ID		Sample			Asbestos Type			Extent	
As sample		As 003			No asbestos detected			12m2	
Material Risk					Priority Risk				Total risk
Asbestos Product	Damage to Asbestos	Surface Treatment	Asbestos Type	Total Material Score	Room Activity	Room Accessibility	Room Frequency of Use	Room Maintenance Frequency	Total Priority Risk Assessment
N/A	N/A	N/A	N/A	N/A	N/A	N/A	N/A	N/A	N/A
Risk Category		N/A			Inspection Regime			N/A

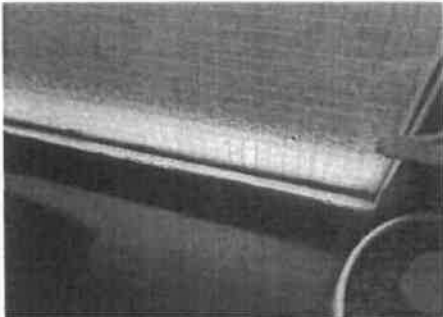
Building / Floor: Offices 1 / Ground Area: R03 Office Location: Windows Product: Resin Description: Sealant to windows Recommended Action: No action required				
Level of ID		Sample			Asbestos Type			Extent	
As sample		As 002			No asbestos detected				
Material Risk					Priority Risk				Total risk
Asbestos Product	Damage to Asbestos	Surface Treatment	Asbestos Type	Total Material Score	Room Activity	Room Accessibility	Room Frequency of Use	Room Maintenance Frequency	Total Priority Risk Assessment
N/A	N/A	N/A	N/A	N/A	N/A	N/A	N/A	N/A	N/A
Risk Category		N/A			Inspection Regime			N/A

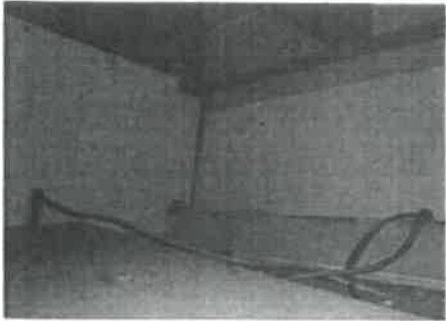
<p>Building / Floor: Offices 1 / Ground Area: R05 Circulation Location: Ceiling void Product: Board Description: Supalux lining to walls Recommended Action: No action required</p>				
Level of ID		Sample			Asbestos Type		Extent		
As sample		As 001			No asbestos detected		6m2		
Material Risk					Priority Risk				Total risk
Asbestos Product	Damage to Asbestos	Surface Treatment	Asbestos Type	Total Material Score	Room Activity	Room Accessibility	Room Frequency of Use	Room Maintenance Frequency	Total Priority Risk Assessment
N/A	N/A	N/A	N/A	N/A	N/A	N/A	N/A	N/A	N/A
Risk Category		N/A			Inspection Regime		N/A

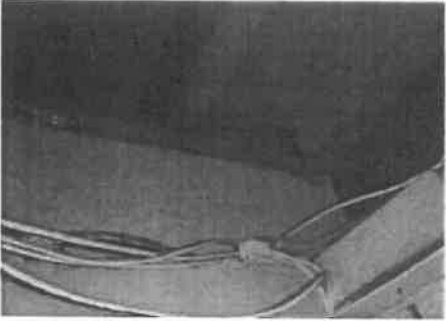
<p>Building / Floor: Offices 1 / Ground Area: R06 Entrance Location: Ceiling void Product: Board Description: Supalux lining to walls Recommended Action: No action required</p>				
Level of ID		Sample			Asbestos Type		Extent		
As sample		As 001			No asbestos detected		4m2		
Material Risk					Priority Risk				Total risk
Asbestos Product	Damage to Asbestos	Surface Treatment	Asbestos Type	Total Material Score	Room Activity	Room Accessibility	Room Frequency of Use	Room Maintenance Frequency	Total Priority Risk Assessment
N/A	N/A	N/A	N/A	N/A	N/A	N/A	N/A	N/A	N/A
Risk Category		N/A			Inspection Regime			N/A

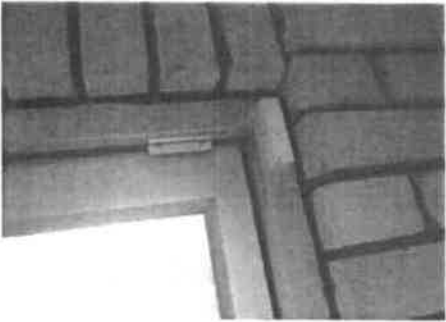
<p>Building / Floor: Offices 1 / Ground Area: R06 Entrance Location: Walls Product: Resin Description: Sealant to door frame Recommended Action: No action required</p>				
Level of ID		Sample			Asbestos Type		Extent		
As sample		As 002			No asbestos detected				
Material Risk					Priority Risk				Total risk
Asbestos Product	Damage to Asbestos	Surface Treatment	Asbestos Type	Total Material Score	Room Activity	Room Accessibility	Room Frequency of Use	Room Maintenance Frequency	Total Priority Risk Assessment
N/A	N/A	N/A	N/A	N/A	N/A	N/A	N/A	N/A	N/A
Risk Category		N/A			Inspection Regime			N/A

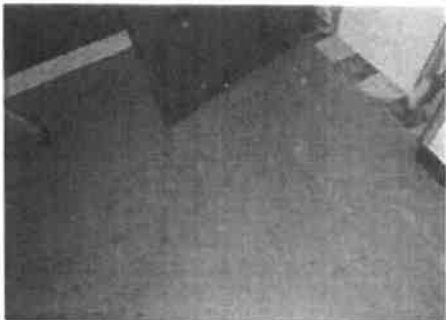
<p>Building / Floor: Offices 1 / First Area: R09 Canteen Location: Floor Product: Vinyl Description: Grey vinyl overlay on timber panel Recommended Action: No action required</p>
---	--

Level of ID		Sample			Asbestos Type			Extent	
Sample		004			No asbestos detected			10m2	
Material Risk					Priority Risk				Total risk
Asbestos Product	Damage to Asbestos	Surface Treatment	Asbestos Type	Total Material Score	Room Activity	Room Accessibility	Room Frequency of Use	Room Maintenance Frequency	Total Priority Risk Assessment
N/A	N/A	N/A	N/A	N/A	N/A	N/A	N/A	N/A	N/A
Risk Category		N/A			Inspection Regime			N/A

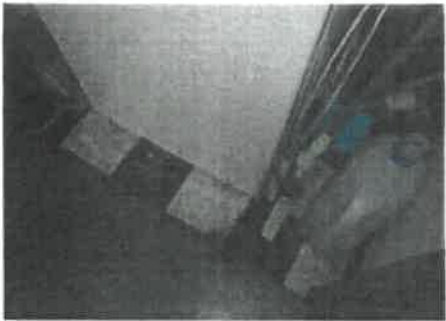
<p>Building / Floor: Offices 1 / First Area: R09a Store room Location: Floor Product: Vinyl Description: Black/white vinyl overlay on timber panel Recommended Action: No action required</p>				
Level of ID		Sample			Asbestos Type			Extent	
Sample		005			No asbestos detected			2m2	
Material Risk					Priority Risk				Total risk
Asbestos Product	Damage to Asbestos	Surface Treatment	Asbestos Type	Total Material Score	Room Activity	Room Accessibility	Room Frequency of Use	Room Maintenance Frequency	Total Priority Risk Assessment
N/A	N/A	N/A	N/A	N/A	N/A	N/A	N/A	N/A	N/A
Risk Category		N/A			Inspection Regime			N/A

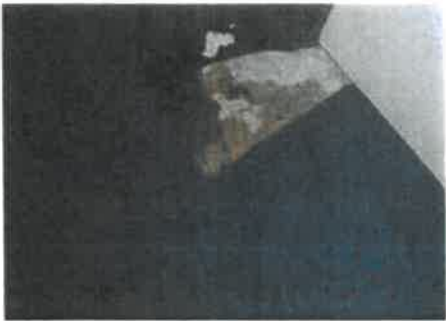
<p>Building / Floor: Offices 1 / First Area: R12 Corridor Location: Floor Product: Resin Description: Adhesive beneath carpet tile overlay (on timber panel) Recommended Action: No action required</p>				
Level of ID		Sample			Asbestos Type			Extent	
Sample		006			No asbestos detected			10m2	
Material Risk					Priority Risk				Total risk
Asbestos Product	Damage to Asbestos	Surface Treatment	Asbestos Type	Total Material Score	Room Activity	Room Accessibility	Room Frequency of Use	Room Maintenance Frequency	Total Priority Risk Assessment
N/A	N/A	N/A	N/A	N/A	N/A	N/A	N/A	N/A	N/A
Risk Category		N/A			Inspection Regime			N/A

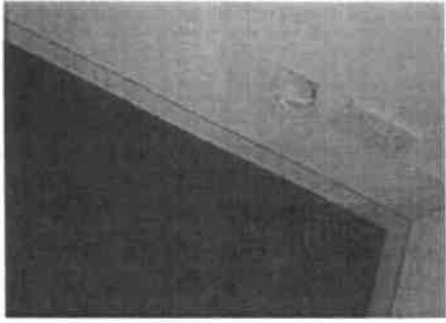
<p>Building / Floor: Offices 1 / First Area: R14 Office Location: Windows Product: Resin Description: Sealant to windows Recommended Action: No action required</p>
---	---

Level of ID		Sample			Asbestos Type			Extent	
As sample		As 002			No asbestos detected				
Material Risk					Priority Risk				Total risk
Asbestos Product	Damage to Asbestos	Surface Treatment	Asbestos Type	Total Material Score	Room Activity	Room Accessibility	Room Frequency of Use	Room Maintenance Frequency	Total Priority Risk Assessment
N/A	N/A	N/A	N/A	N/A	N/A	N/A	N/A	N/A	N/A
Risk Category		N/A			Inspection Regime			N/A

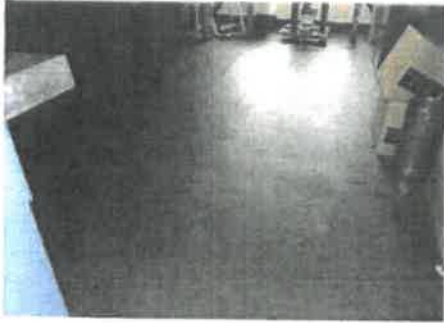
<p>Building / Floor: Offices 2 / Ground Area: R04 Coridor Location: Floor Product: Vinyl Description: Brown vinyl tiles on concrete Recommended Action: No action required</p>
---	--

Level of ID		Sample			Asbestos Type			Extent	
Sample		008			No asbestos detected			70m2	
Material Risk					Priority Risk				Total risk
Asbestos Product	Damage to Asbestos	Surface Treatment	Asbestos Type	Total Material Score	Room Activity	Room Accessibility	Room Frequency of Use	Room Maintenance Frequency	Total Priority Risk Assessment
N/A	N/A	N/A	N/A	N/A	N/A	N/A	N/A	N/A	N/A
Risk Category		N/A			Inspection Regime			N/A

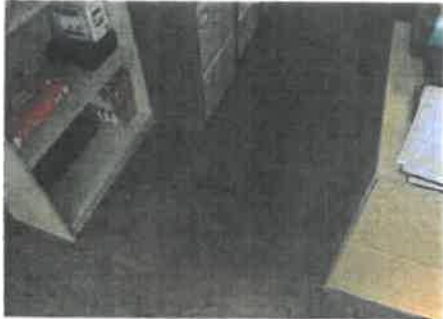
<p>Building / Floor: Offices 2 / Ground</p> <p>Area: R08</p> <p>Location: Floor</p> <p>Product: Vinyl</p> <p>Description: Brown vinyl tiles below carpet overlay</p> <p>Recommended Action: No action required</p>
---	--

Level of ID		Sample			Asbestos Type			Extent	
As sample		As 008			No asbestos detected			20m2	
Material Risk					Priority Risk				Total risk
Asbestos Product	Damage to Asbestos	Surface Treatment	Asbestos Type	Total Material Score	Room Activity	Room Accessibility	Room Frequency of Use	Room Maintenance Frequency	Total Priority Risk Assessment
N/A	N/A	N/A	N/A	N/A	N/A	N/A	N/A	N/A	N/A
Risk Category		N/A			Inspection Regime			N/A

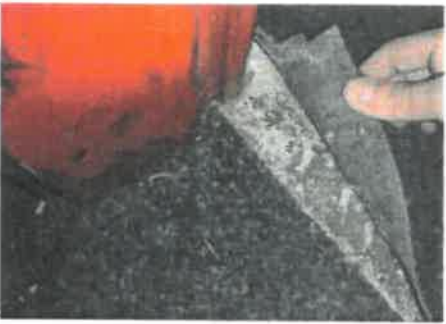
Building / Floor: Offices 2 / Ground Area: R10 Canteen Location: Floor Product: Vinyl Description: Brown vinyl tiles- painted blue Recommended Action: No action required				
Level of ID		Sample			Asbestos Type			Extent	
As sample		As 008			No asbestos detected			30m2	
Material Risk					Priority Risk				Total risk
Asbestos Product	Damage to Asbestos	Surface Treatment	Asbestos Type	Total Material Score	Room Activity	Room Accessibility	Room Frequency of Use	Room Maintenance Frequency	Total Priority Risk Assessment
N/A	N/A	N/A	N/A	N/A	N/A	N/A	N/A	N/A	N/A
Risk Category		N/A			Inspection Regime			N/A

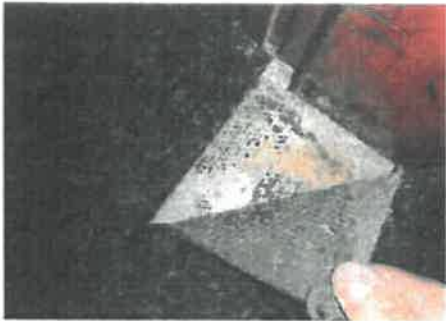
Building / Floor: Offices 2 / Ground Area: R12 Location: Floor Product: Vinyl Description: Brown vinyl tiles below carpet overlay Recommended Action: No action required				
Level of ID		Sample			Asbestos Type			Extent	
As sample		As 008			No asbestos detected			6m2	
Material Risk					Priority Risk				Total risk
Asbestos Product	Damage to Asbestos	Surface Treatment	Asbestos Type	Total Material Score	Room Activity	Room Accessibility	Room Frequency of Use	Room Maintenance Frequency	Total Priority Risk Assessment
N/A	N/A	N/A	N/A	N/A	N/A	N/A	N/A	N/A	N/A
Risk Category		N/A			Inspection Regime			N/A

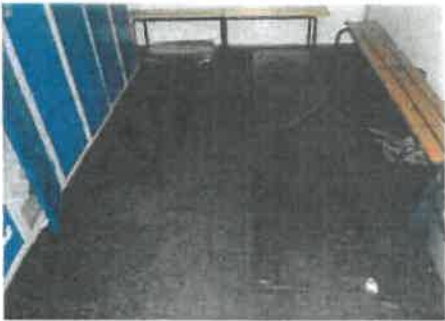
<p>Building / Floor: Offices 2 / Ground Area: R13 Office Location: Floor Product: Vinyl Description: Brown vinyl tiles below carpet overlay Recommended Action: No action required</p>				
Level of ID		Sample		Asbestos Type		Extent			
As sample		As 008		No asbestos detected		15m2			
Material Risk					Priority Risk				Total risk
Asbestos Product	Damage to Asbestos	Surface Treatment	Asbestos Type	Total Material Score	Room Activity	Room Accessibility	Room Frequency of Use	Room Maintenance Frequency	Total Priority Risk Assessment
N/A	N/A	N/A	N/A	N/A	N/A	N/A	N/A	N/A	N/A
Risk Category		N/A			Inspection Regime			N/A

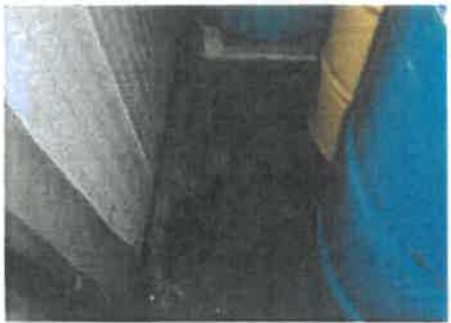
<p>Building / Floor: Offices 2 / Ground Area: R15 Locker room Location: Floor Product: Vinyl Description: Brown vinyl tiles below carpet overlay Recommended Action: No action required</p>				
Level of ID		Sample		Asbestos Type		Extent			
As sample		As 008		No asbestos detected		20m2			
Material Risk					Priority Risk				Total risk
Asbestos Product	Damage to Asbestos	Surface Treatment	Asbestos Type	Total Material Score	Room Activity	Room Accessibility	Room Frequency of Use	Room Maintenance Frequency	Total Priority Risk Assessment
N/A	N/A	N/A	N/A	N/A	N/A	N/A	N/A	N/A	N/A
Risk Category		N/A			Inspection Regime			N/A

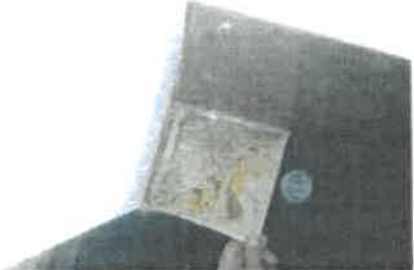
<p>Building / Floor: Offices 2 / Ground Area: R16 Drying room Location: Floor Product: Vinyl Description: Brown vinyl tiles on concrete Recommended Action: No action required</p>				
Level of ID		Sample		Asbestos Type			Extent		
As sample		As 008		No asbestos detected			20m2		
Material Risk					Priority Risk				Total risk
Asbestos Product	Damage to Asbestos	Surface Treatment	Asbestos Type	Total Material Score	Room Activity	Room Accessibility	Room Frequency of Use	Room Maintenance Frequency	Total Priority Risk Assessment
N/A	N/A	N/A	N/A	N/A	N/A	N/A	N/A	N/A	N/A
Risk Category		N/A			Inspection Regime			N/A

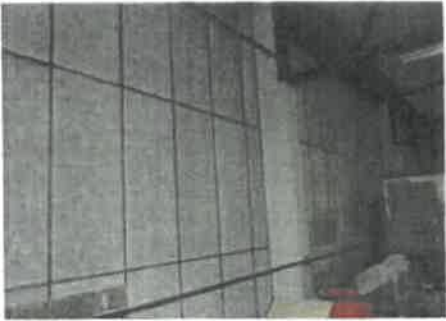
<p>Building / Floor: Offices 2 / First Area: R18 Store Location: Ceiling Product: Cement Description: Preformed corrugated sheets above plasterboard ceiling panels Recommended Action: Label as containing asbestos & manage in situ. Inspect & record condition at recommended intervals. Repairs/removals must be carried out by appropriately qualified persons under controlled conditions.</p>				
Level of ID		Sample			Asbestos Type			Extent	
Strongly presumed		SP1			Chrysotile			Throughout	
Material Risk					Priority Risk				Total risk
Asbestos Product	Damage to Asbestos	Surface Treatment	Asbestos Type	Total Material Score	Room Activity	Room Accessibility	Room Frequency of Use	Room Maintenance Frequency	Total Priority Risk Assessment
1	0	1	1	3	1	2	2	0	8
Risk Category		Very low risk			Inspection Regime			12 monthly

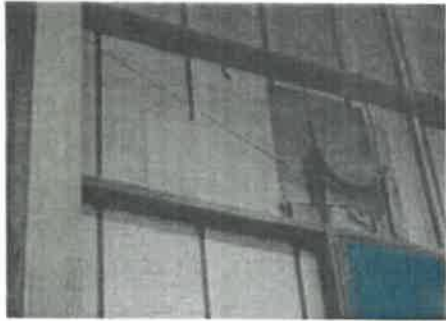
Building / Floor: Warehouse / Ground Area: Area 1 Location: Walls Product: Board Description: Supalux panel lining to wall Recommended Action: No action required				
Level of ID		Sample			Asbestos Type			Extent	
As sample		As 011			No asbestos detected			120m2	
Material Risk					Priority Risk				Total risk
Asbestos Product	Damage to Asbestos	Surface Treatment	Asbestos Type	Total Material Score	Room Activity	Room Accessibility	Room Frequency of Use	Room Maintenance Frequency	Total Priority Risk Assessment
N/A	N/A	N/A	N/A	N/A	N/A	N/A	N/A	N/A	N/A
Risk Category		N/A			Inspection Regime			N/A

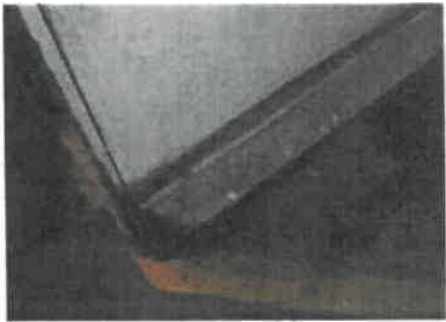
Building / Floor: Warehouse / Ground Area: Area 1 Location: Machinery Product: Gasket Description: Presumed gaskets to flanges Recommended Action: Label as potentially containing asbestos. Monitor & record the condition at regular intervals. Further investigation required prior to any works being carried out that may disturb this material.				
Level of ID		Sample			Asbestos Type			Extent	
Presumed		P2			Presumed			All flanges	
Material Risk					Priority Risk				Total risk
Asbestos Product	Damage to Asbestos	Surface Treatment	Asbestos Type	Total Material Score	Room Activity	Room Accessibility	Room Frequency of Use	Room Maintenance Frequency	Total Priority Risk Assessment
2	0	1	1	4	1	1	2	0	8
Risk Category		Very low risk			Inspection Regime			12 monthly

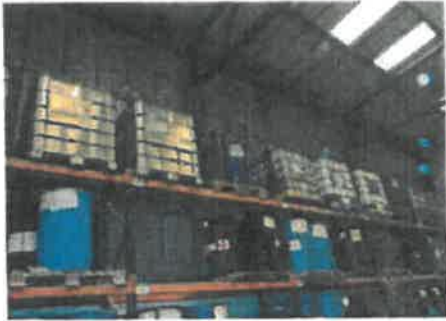
<p>Building / Floor: Warehouse / Ground Area: Area 2 Location: Ceiling Product: Cement Description: Preformed corrugated sheets above plasterboard ceiling panels Recommended Action: Label as containing asbestos & manage in situ. Inspect & record condition at recommended intervals. Repairs/removals must be carried out by appropriately qualified persons under controlled conditions.</p>				
Level of ID		Sample			Asbestos Type			Extent	
Strongly presumed		SP3			Chrysotile			Throughout	
Material Risk					Priority Risk				Total risk
Asbestos Product	Damage to Asbestos	Surface Treatment	Asbestos Type	Total Material Score	Room Activity	Room Accessibility	Room Frequency of Use	Room Maintenance Frequency	Total Priority Risk Assessment
1	0	1	1	3	1	2	2	0	8
Risk Category		Very low risk			Inspection Regime			12 monthly

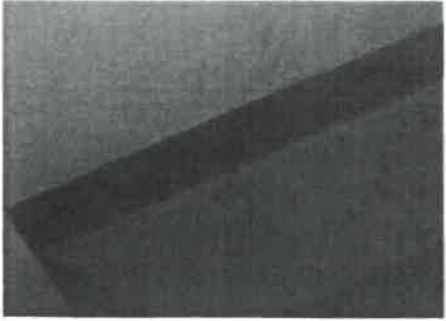
<p>Building / Floor: Warehouse / Ground Area: Area 2 Location: Walls Product: Board Description: Supalux panel lining to wall Recommended Action: No action required</p>				
Level of ID		Sample			Asbestos Type			Extent	
As sample		As 011			No asbestos detected			<500m2	
Material Risk					Priority Risk				Total risk
Asbestos Product	Damage to Asbestos	Surface Treatment	Asbestos Type	Total Material Score	Room Activity	Room Accessibility	Room Frequency of Use	Room Maintenance Frequency	Total Priority Risk Assessment
N/A	N/A	N/A	N/A	N/A	N/A	N/A	N/A	N/A	N/A
Risk Category		N/A			Inspection Regime			N/A

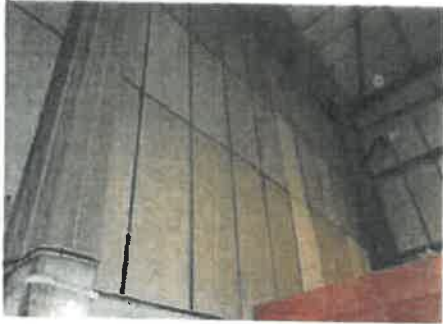
Building / Floor: Warehouse / Ground Area: Area 3 Location: Ceiling Product: Cement Description: Preformed corrugated sheets above plasterboard ceiling panels Recommended Action: Label as containing asbestos & manage in situ. Inspect & record condition at recommended intervals. Repairs/removals must be carried out by appropriately qualified persons under controlled conditions.				
Level of ID		Sample			Asbestos Type		Extent		
Strongly presumed		SP4			Chrysotile		Throughout		
Material Risk					Priority Risk				Total risk
Asbestos Product	Damage to Asbestos	Surface Treatment	Asbestos Type	Total Material Score	Room Activity	Room Accessibility	Room Frequency of Use	Room Maintenance Frequency	Total Priority Risk Assessment
1	0	1	1	3	1	2	2	0	8
Risk Category		Very low risk			Inspection Regime			12 monthly

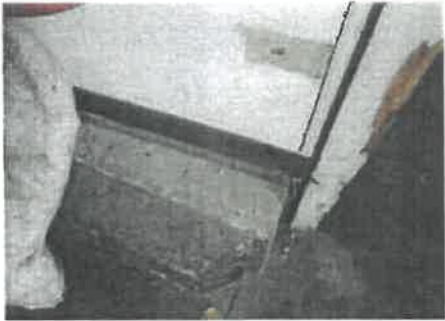
Building / Floor: Warehouse / Ground Area: Area 3 Location: Floor Product: Vinyl Description: Vinyl skirting to wall Recommended Action: No action required				
Level of ID		Sample			Asbestos Type			Extent	
As sample		As 012			No asbestos detected			30 Lm	
Material Risk					Priority Risk				Total risk
Asbestos Product	Damage to Asbestos	Surface Treatment	Asbestos Type	Total Material Score	Room Activity	Room Accessibility	Room Frequency of Use	Room Maintenance Frequency	Total Priority Risk Assessment
N/A	N/A	N/A	N/A	N/A	N/A	N/A	N/A	N/A	N/A
Risk Category		N/A			Inspection Regime			N/A

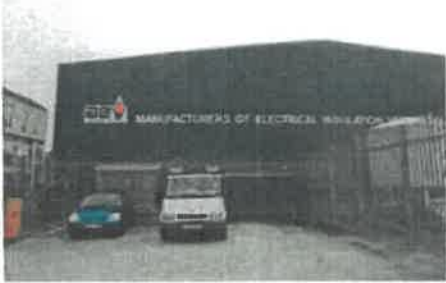
Building / Floor: Whole site Area: External Location: Roof Product: Cement Description: Preformed corrugated sheets (visual from internal) may also be below metal profile sheets Recommended Action: Manage in situ. Inspect & record condition at recommended intervals. Repairs/ removals must be carried out by appropriately qualified persons under controlled conditions.				
					Level of ID		Sample		Asbestos Type
Strongly presumed		SP6		Chrysotile		Throughout			
Material Risk					Priority Risk				Total risk
Asbestos Product	Damage to Asbestos	Surface Treatment	Asbestos Type	Total Material Score	Room Activity	Room Accessibility	Room Frequency of Use	Room Maintenance Frequency	Total Priority Risk Assessment
1	0	1	1	3	1	1	2	0	7
Risk Category		Very low risk			Inspection Regime			12 monthly
